Manhole Inspection Summary

Manhole # S23K__024MH

Location Address: **1508-1500 N Parish St**

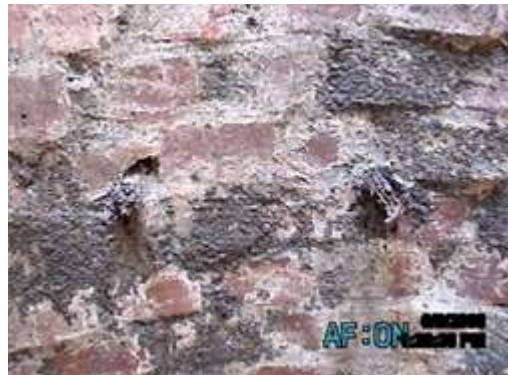
Defect 6

Count: **6** Missing: **3** ☒ **Corroded**

missing rung

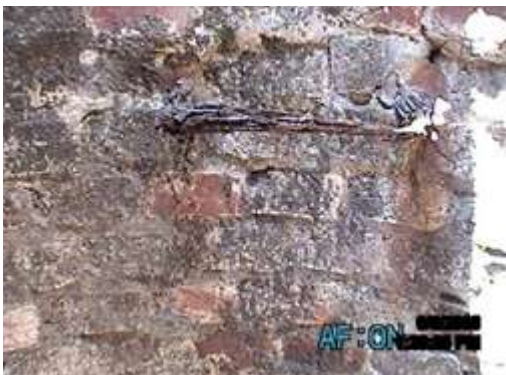
Defect 5

corroded rung

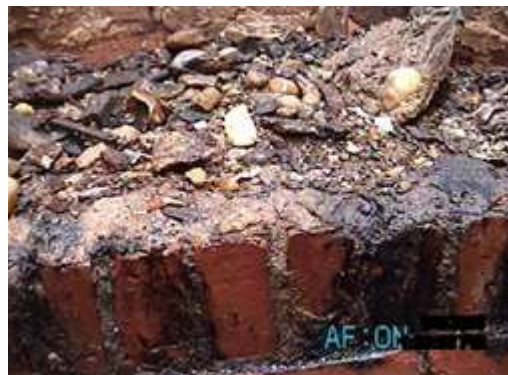
Defect 3

Condition: ☐ Sound ☐ Cracked ☐ Root Intrusion ☐ Deteriorated ☐ Leaks ☒ **Debris**

debris on bench

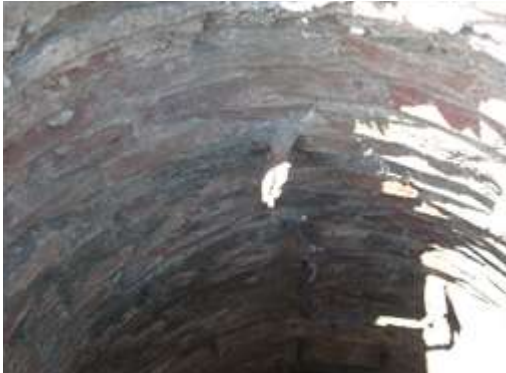
Defect 2

Infiltration: ☐ None ☐ Joint ☐ Cracks ☒ **Mortar** ☐ Roots ☒ **Wall**

infiltration at corbel wall/mortar

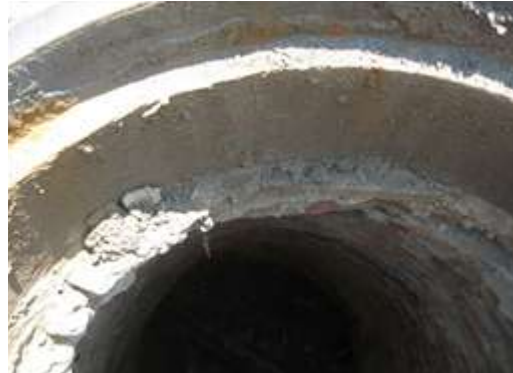
Defect 1

Condition: ☐ Sound ☐ Cracked ☒ **Leaks**

Infiltration: ☐ None ☒ **Joint** ☐ Cracks ☐ Mortar ☐ Roots ☐ Wall

frame-lid leaks, signs of infiltration at joint

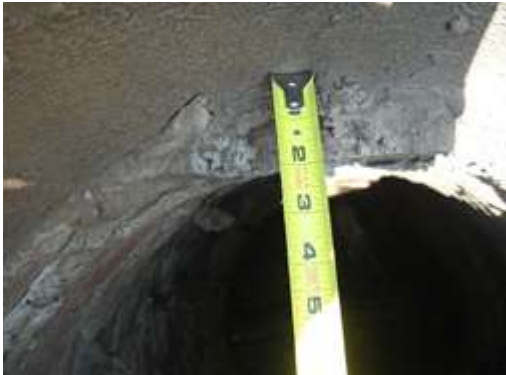
Defect 7

Offset: **2.** (in.)
25

2.25" offset

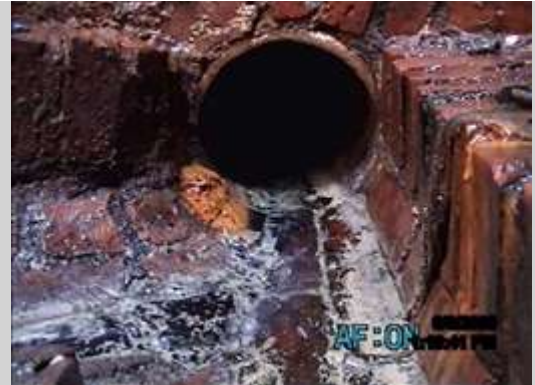
12 O'Clock Outflow

Pipe Height: **8.4** (in.) Rod and Bar (Angled)
Pipe Material: **Clay** ☐ Pipe Lined
Invert Depth: **10.82** (ft.) Flow Characteristics: **Slow**
Deposits: ☒ None ☐ Mud ☐ Sludge ☐ Debris ☐ Grease
Silt Depth: **0** (in.) Deposits Extent:
Infiltration: **None** Pipe Seal Cond: **Sound**

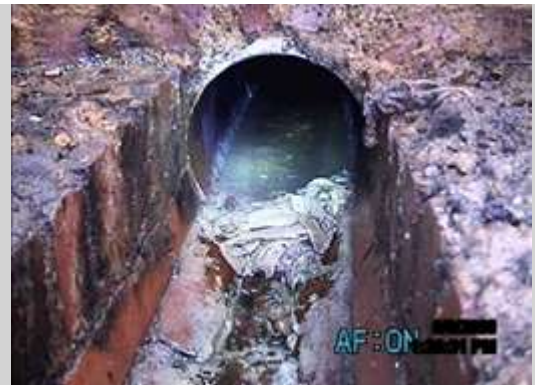
6 O'Clock Inflow

Pipe Height: **8.4** (in.) Rod and Bar (Angled)
Pipe Material: **Clay** ☐ Pipe Lined
Invert Depth: **10.50** (ft.) Flow Characteristics: **Slow**
Deposits: ☒ None ☐ Mud ☐ Sludge ☐ Debris ☐ Grease
Silt Depth: **0** (in.) Deposits Extent:
Infiltration: **None** Pipe Seal Cond: **Sound**

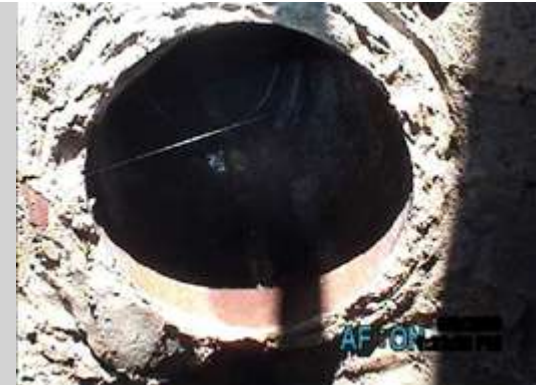
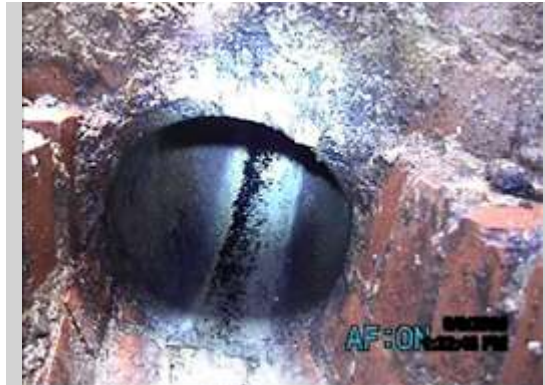
9 O'Clock Inflow

Pipe Height: **10.8** (in.) Rod and Bar (Angled)

Invert Depth: **10.53** (ft.) Flow Characteristics: **None**

Infiltration: **None** Pipe Seal Cond: **Sound**
